# Fergus and Judith Basin Counties Remaining Prospects

Final Report  
Abandoned Mine Reclamation Project

## FERGUS AND JUDITH BASIN COUNTIES REMAINING PROSPECTS ABANDONED MINE RECLAMATION PROJECT

Robert Peccia & Associates, Inc.  
Helena, MT

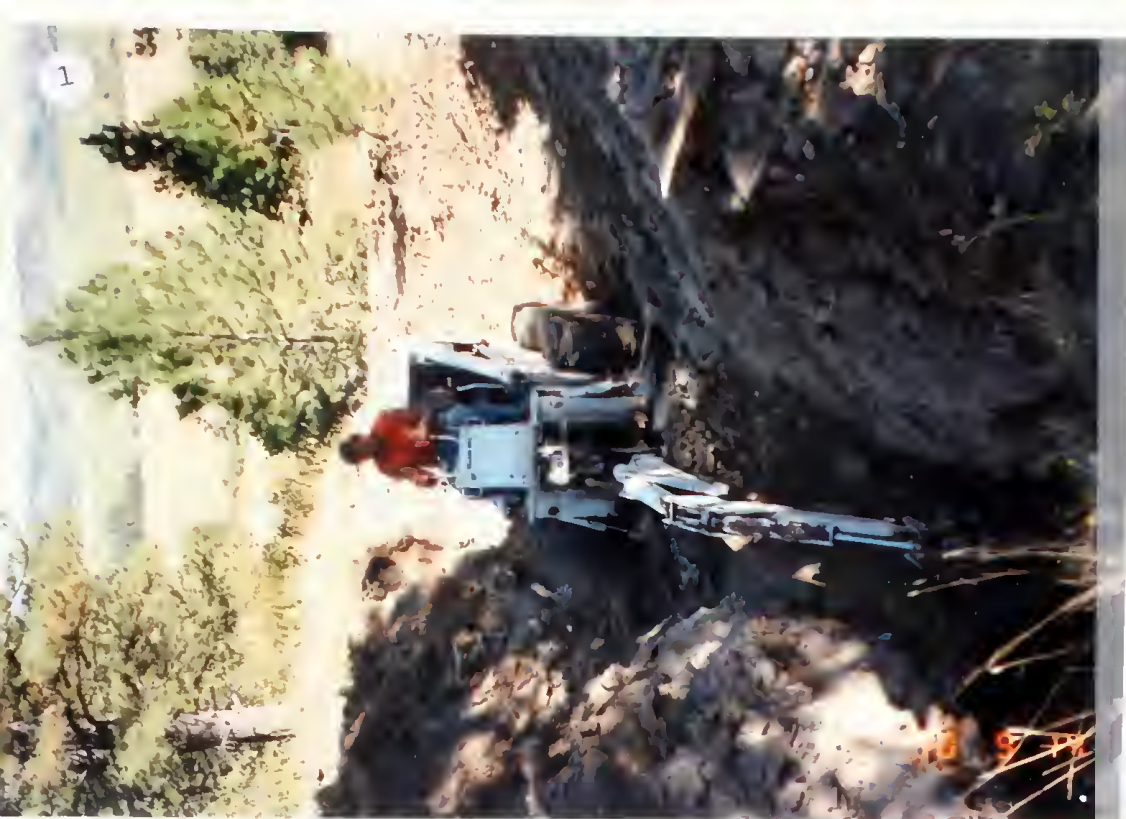
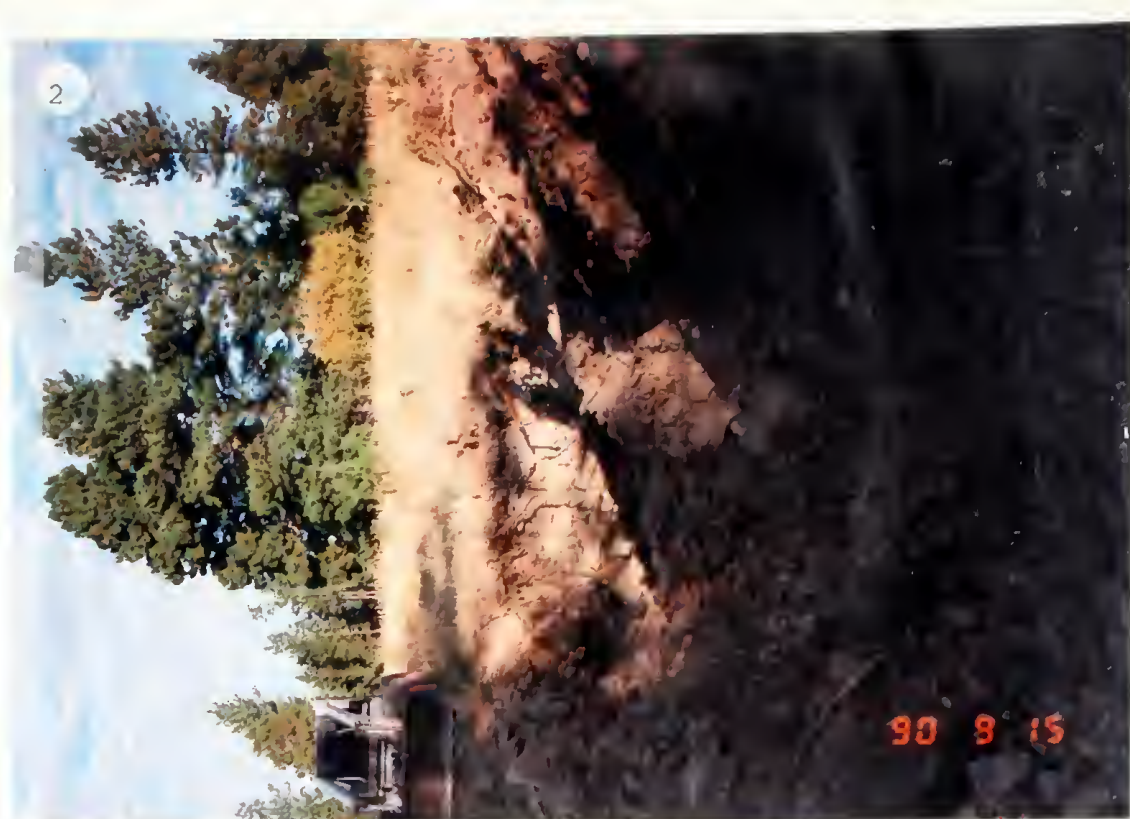
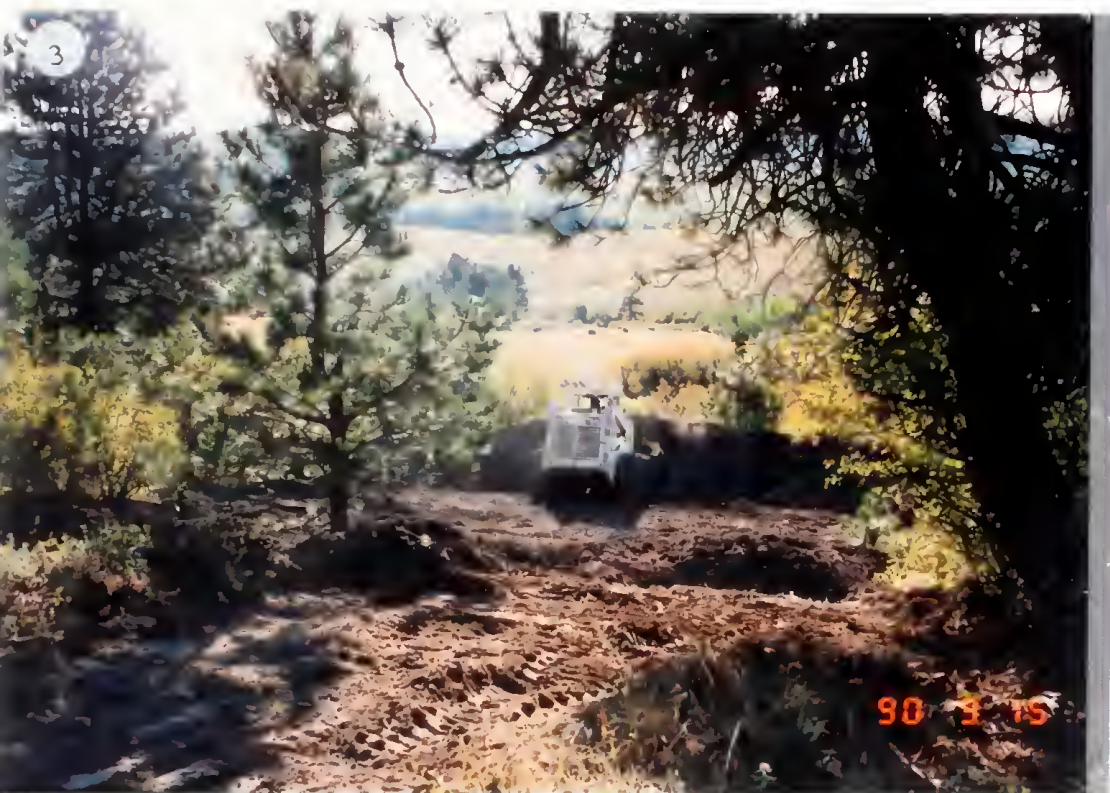
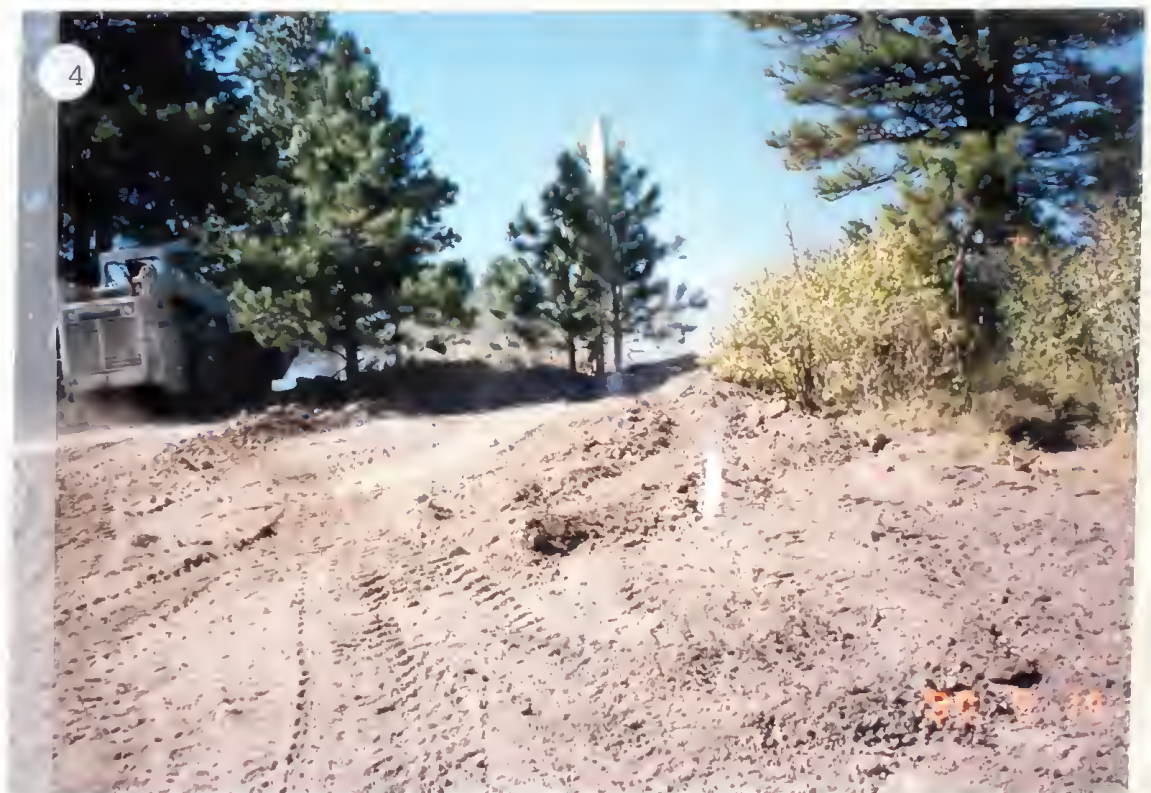
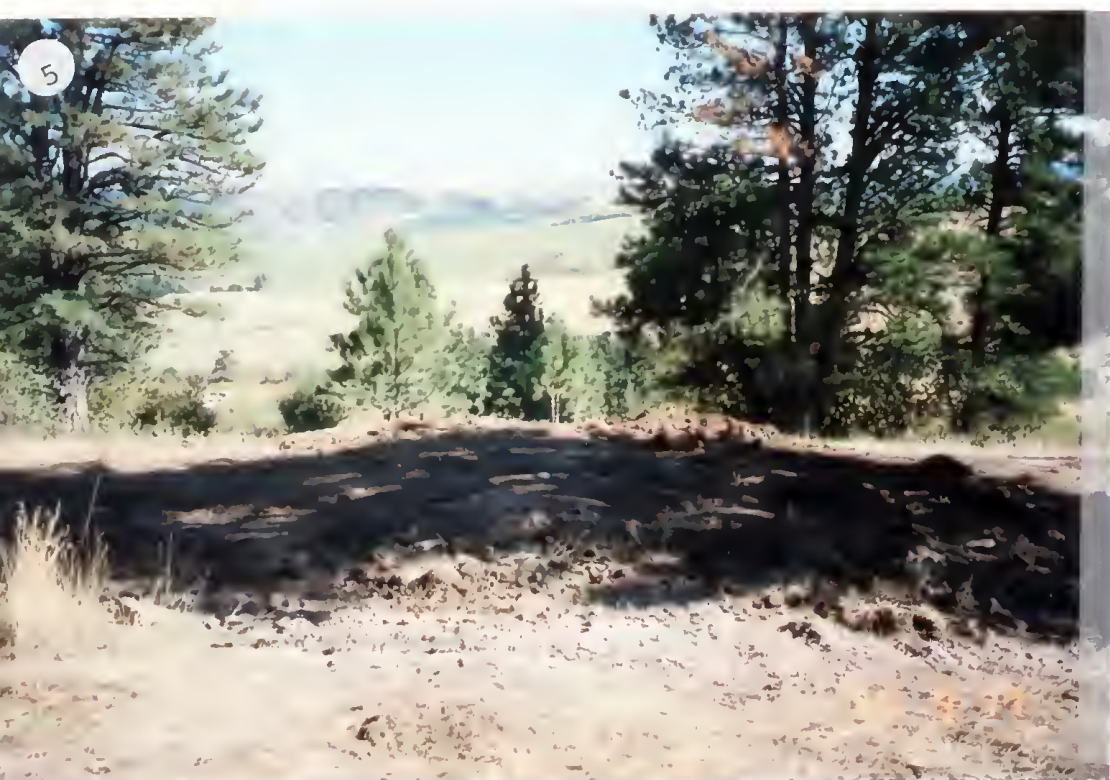
1. Maxell Mine - Adit Preparation
2. Maxell Mine - Adit Closure
3. Maxell Mine - Spoils Deposition
4. Maxell Mine - Lime Incorporation & Grading
5. Maxell Mine - Coversoil Over Adit

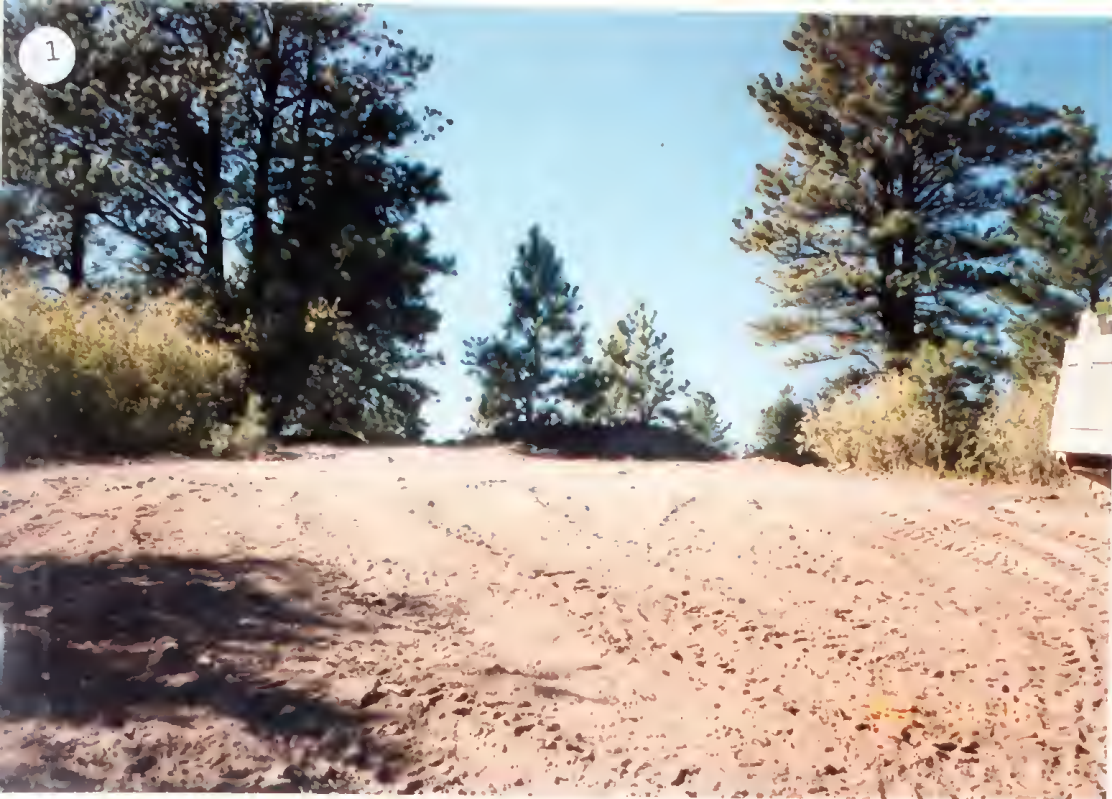
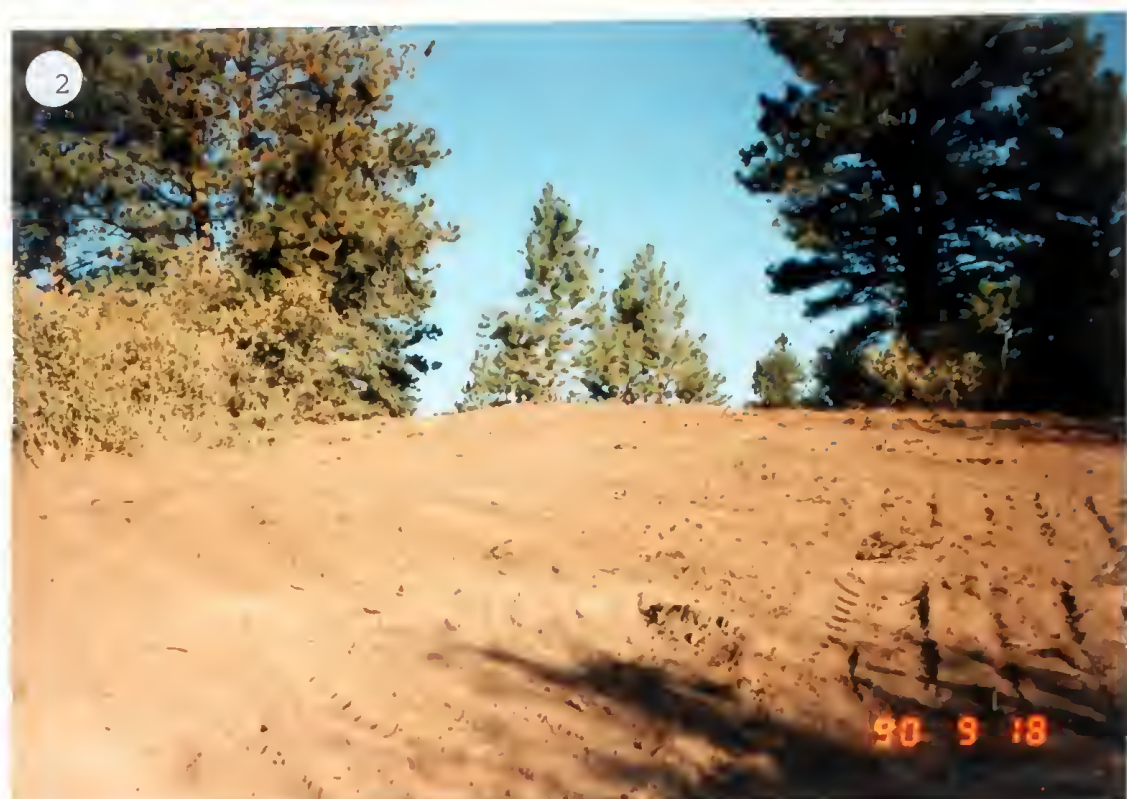
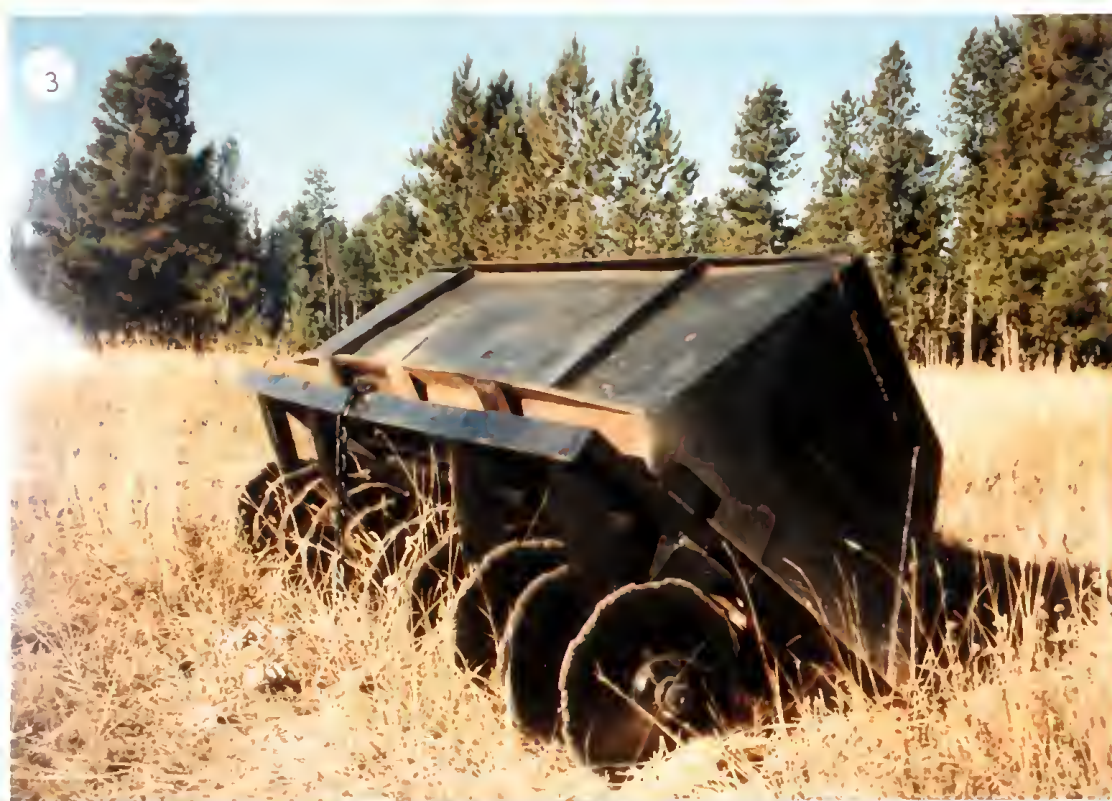
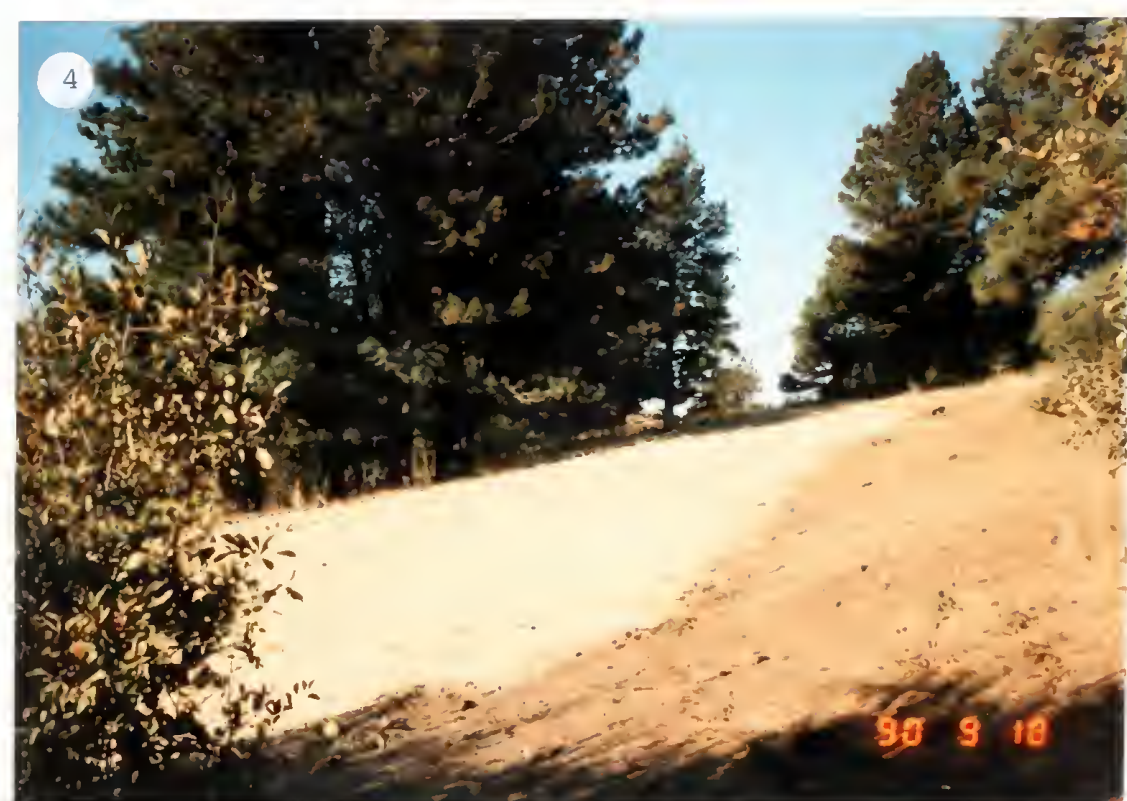
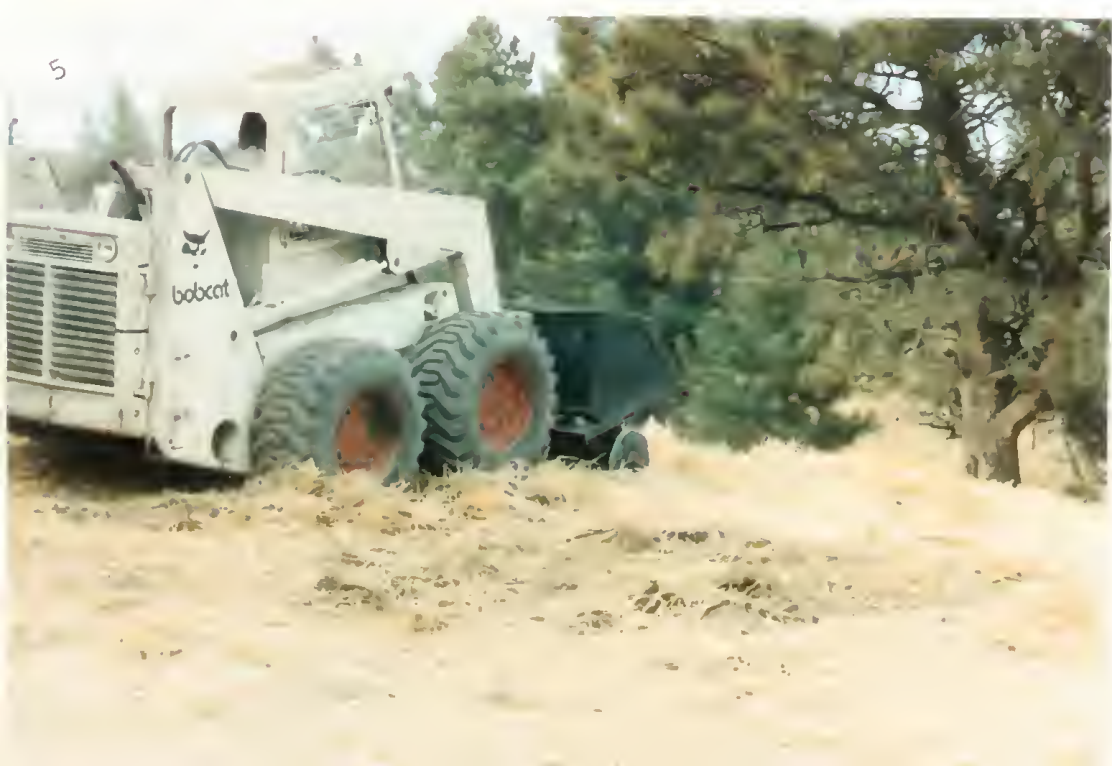
1. Maxwell Mine - Spoils Grading
2. Maxwell Mine - Coversoil Placement
3. Contractor's New Crimping Implement
4. Maxwell Mine - Straw Mulch Spread
5. Maxwell Mine - Straw Mulch Crimping

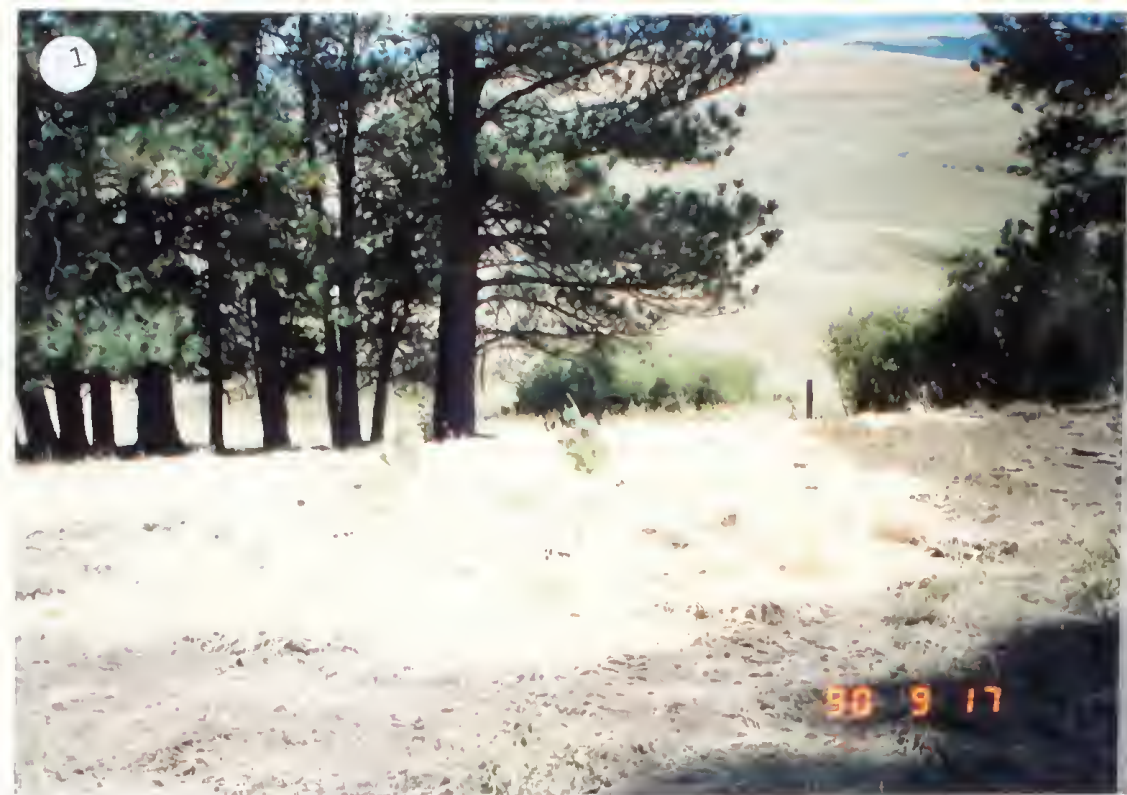
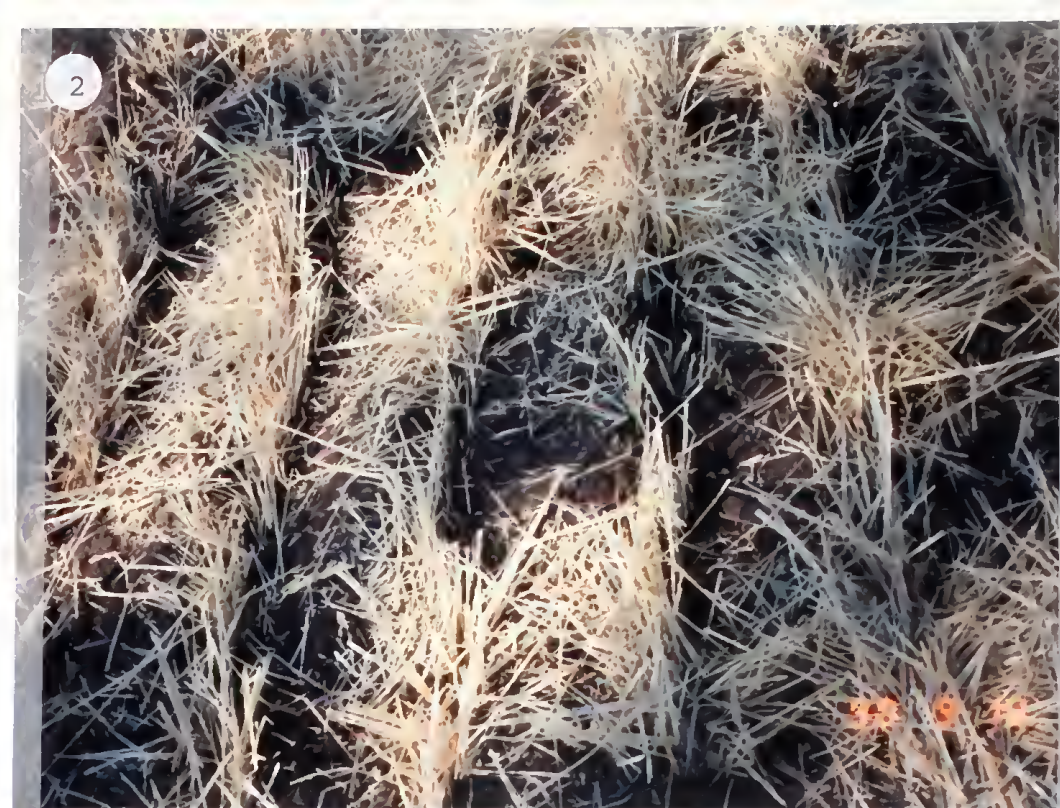
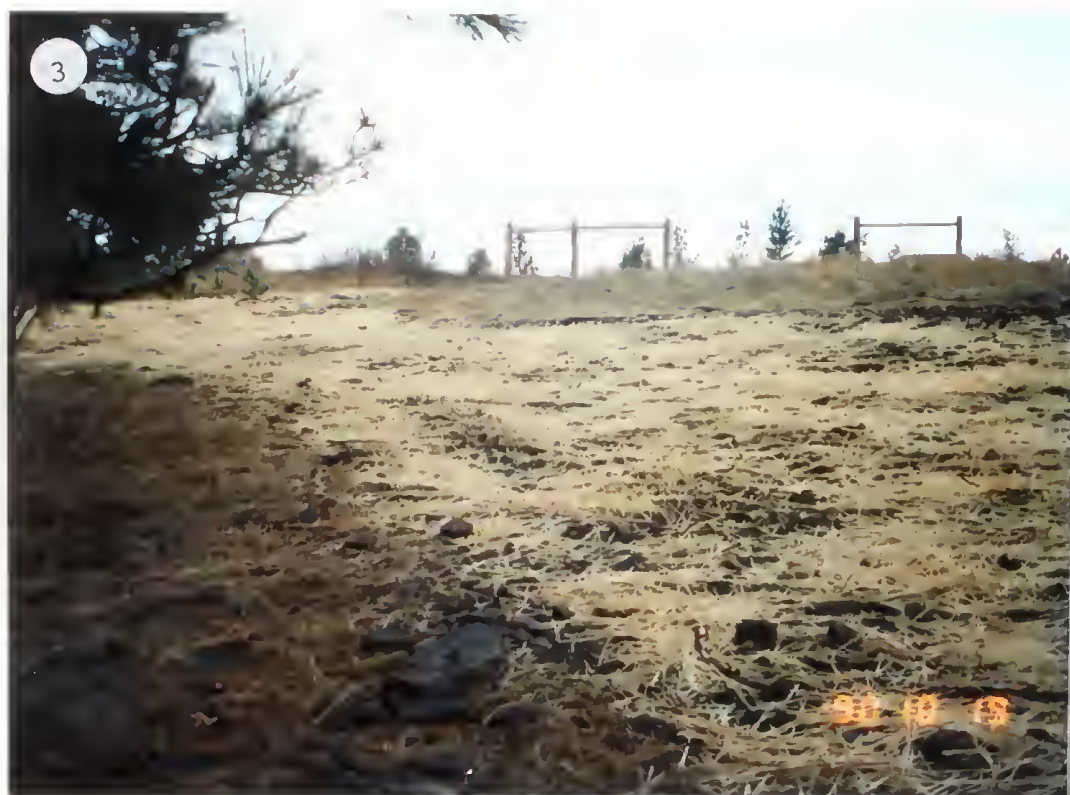
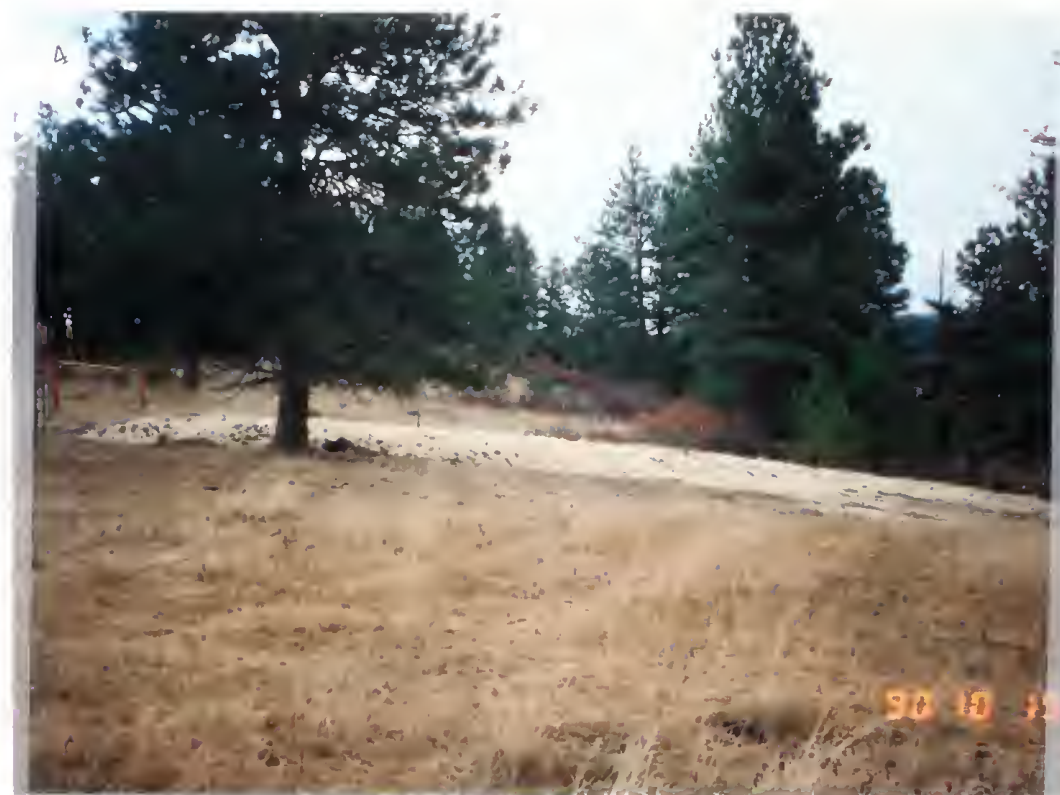
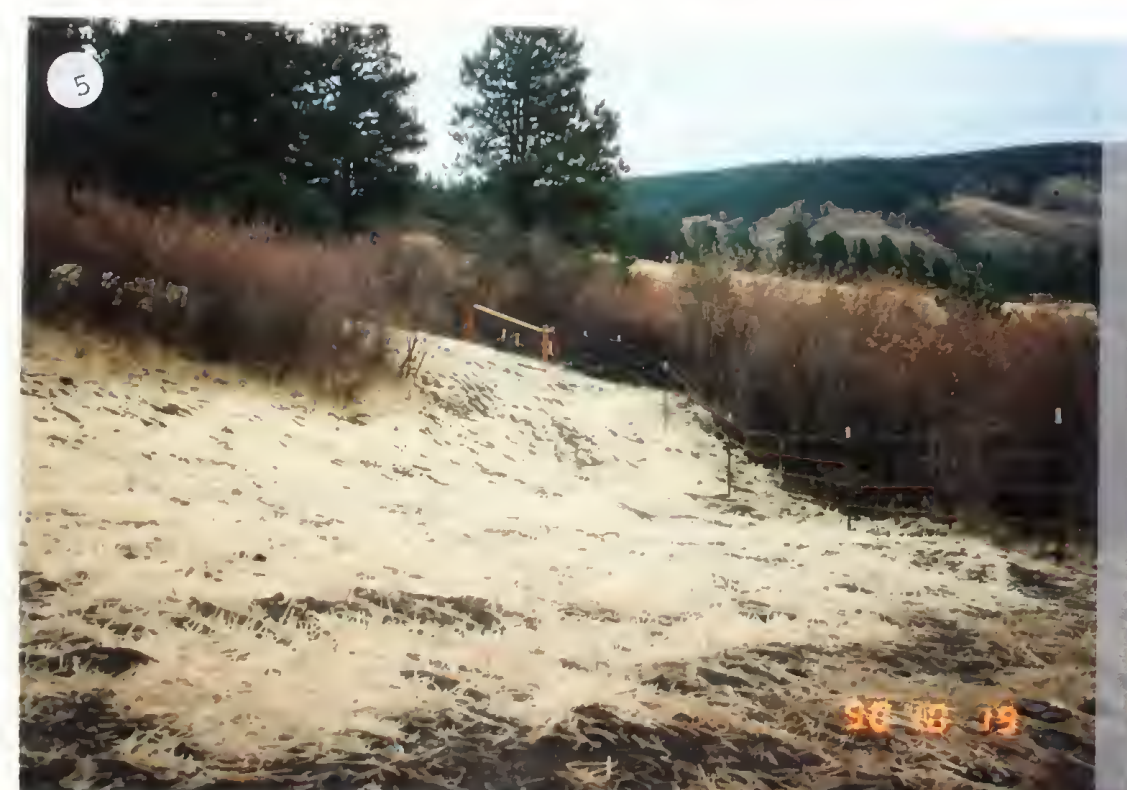
1. Maxwell Mine - Straw Over Regraded Exploratory Prospect
2. Maxwell Mine - Improved Crimping Results
3. Maxwell Mine - After Reclamation
4. Maxwell Mine - After Reclamation
5. Maxwell Mine - After Reclamation

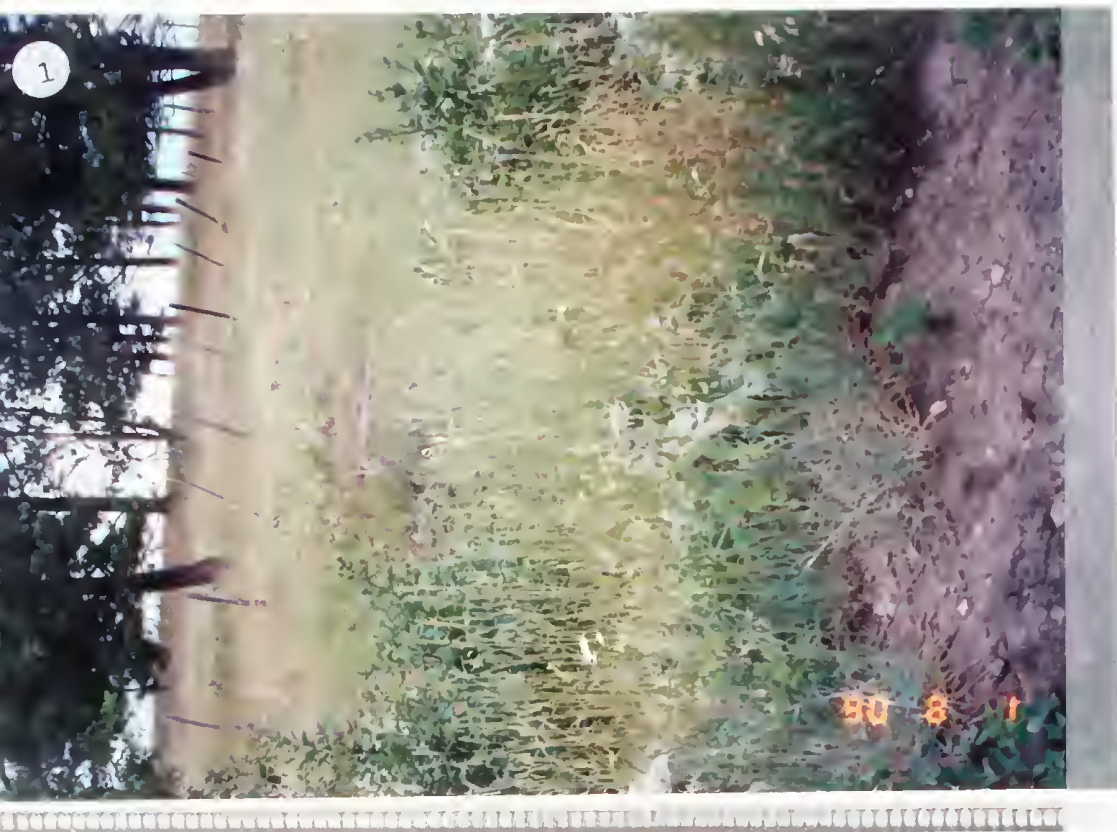
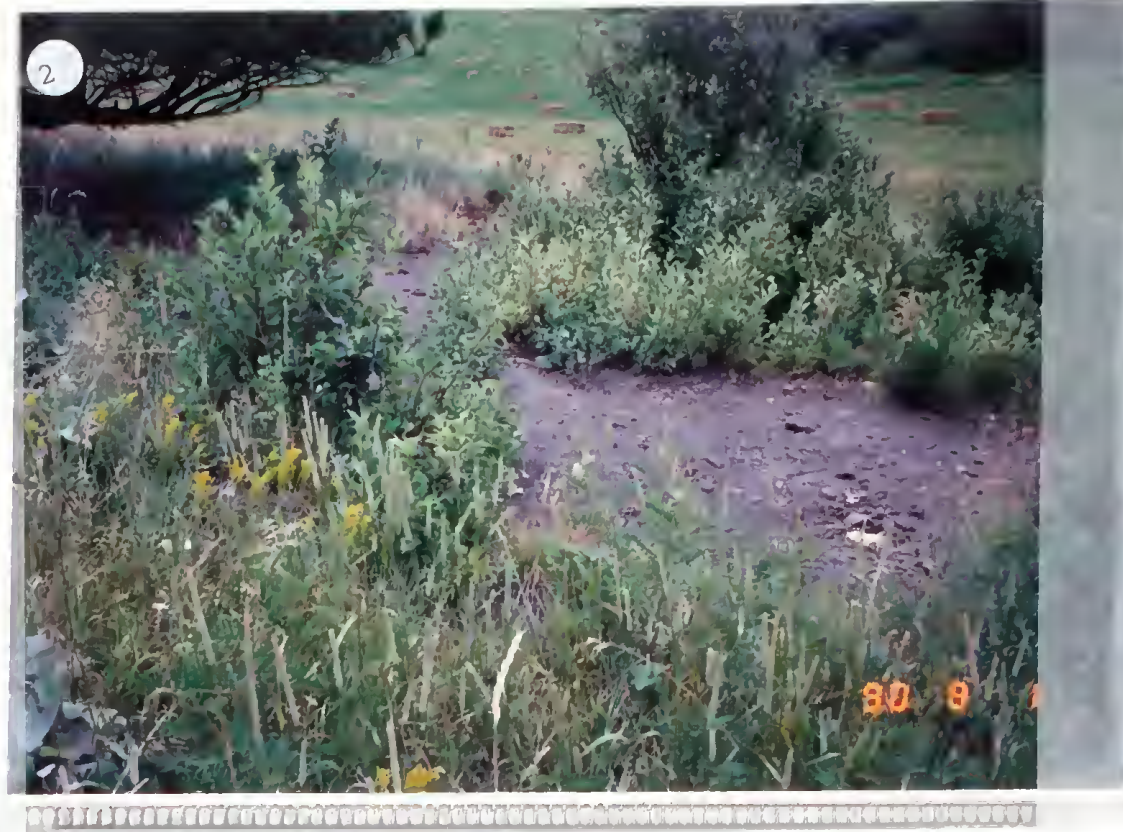
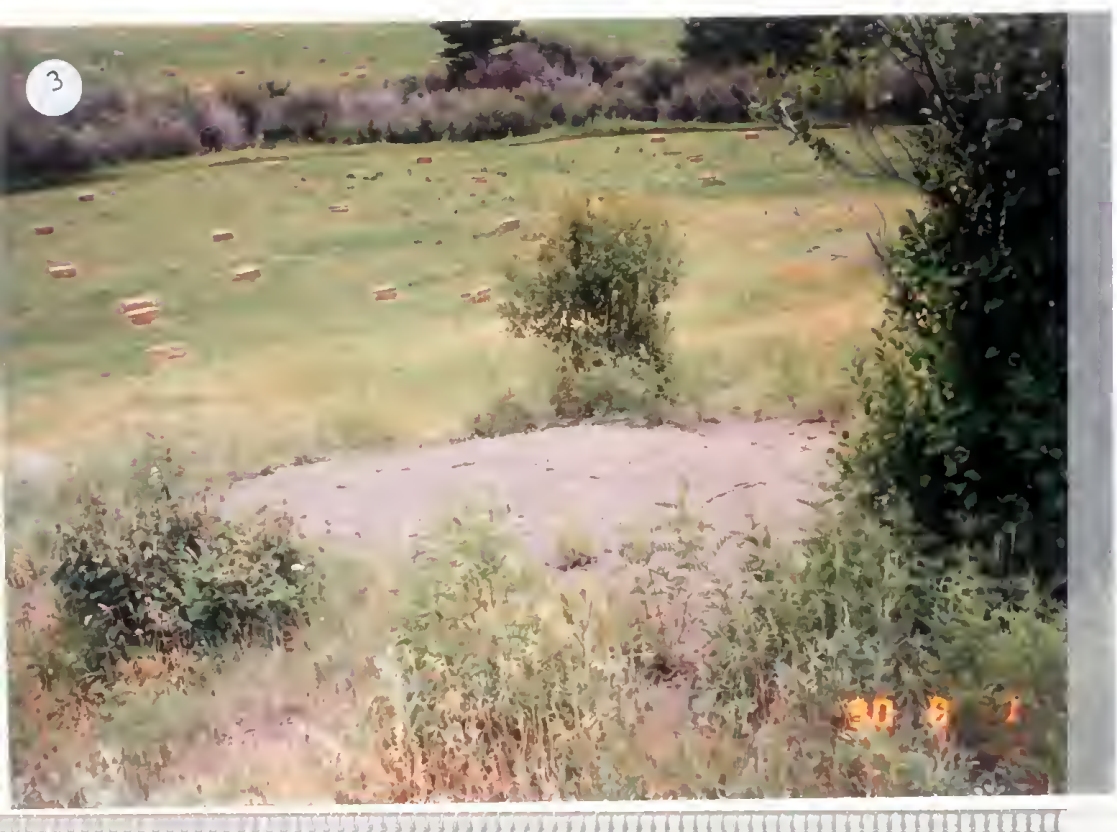
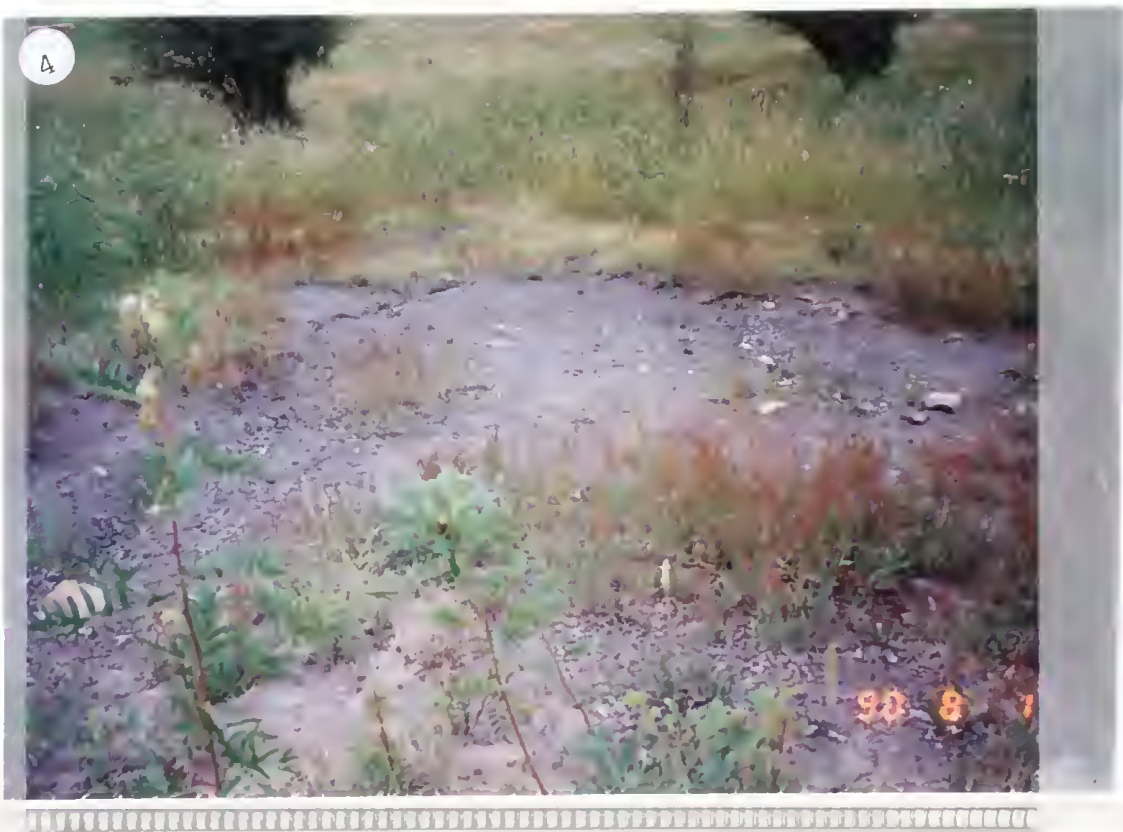
1. Shearson Mines - Site No. 1 Before Construction
2. Shearson Mines - Site No. 1 Before Construction
3. Shearson Mines - Site No. 4 Before Construction
4. Shearson Mines - Site No. 2 Before Construction
5. Shearson Mines - Site No. 3 Before Construction

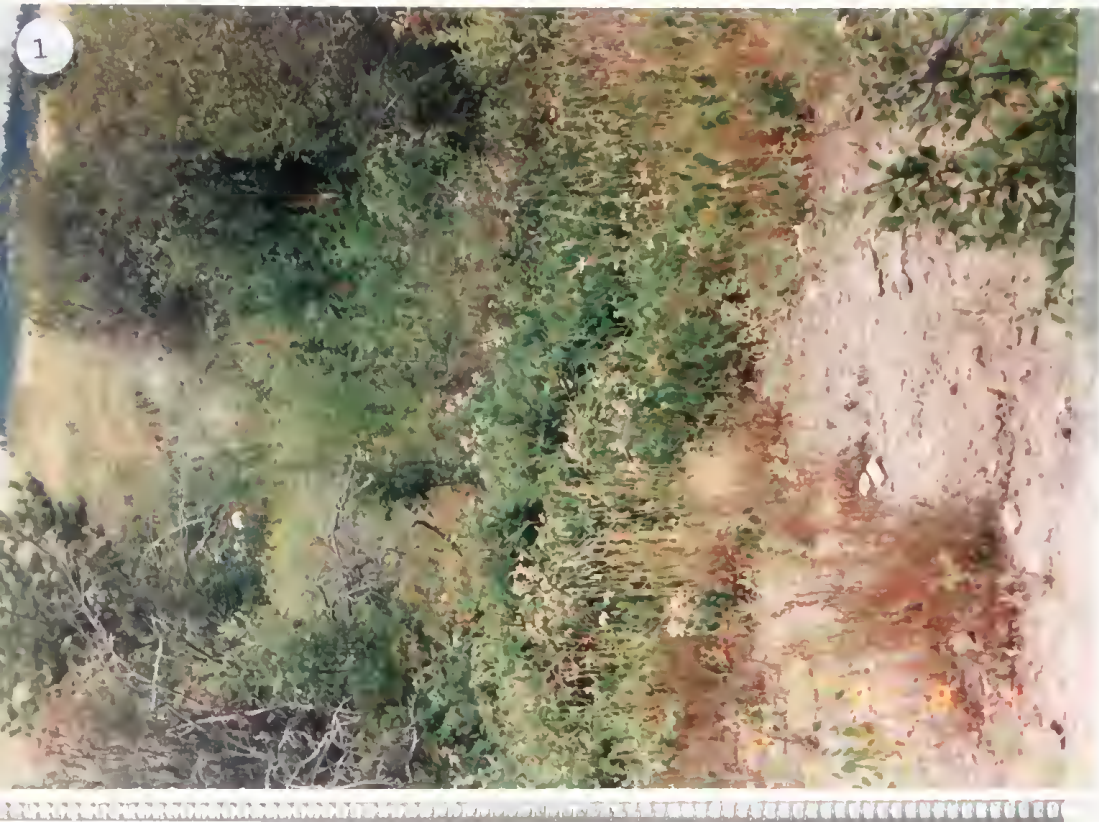
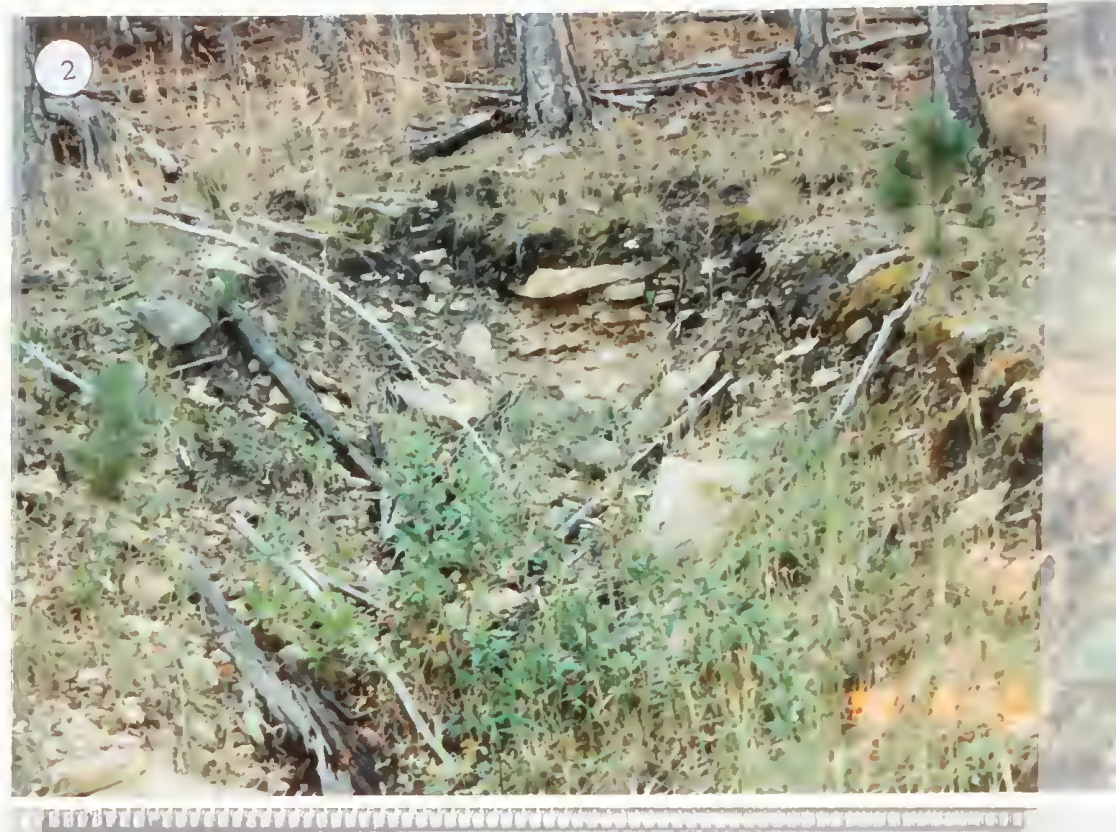
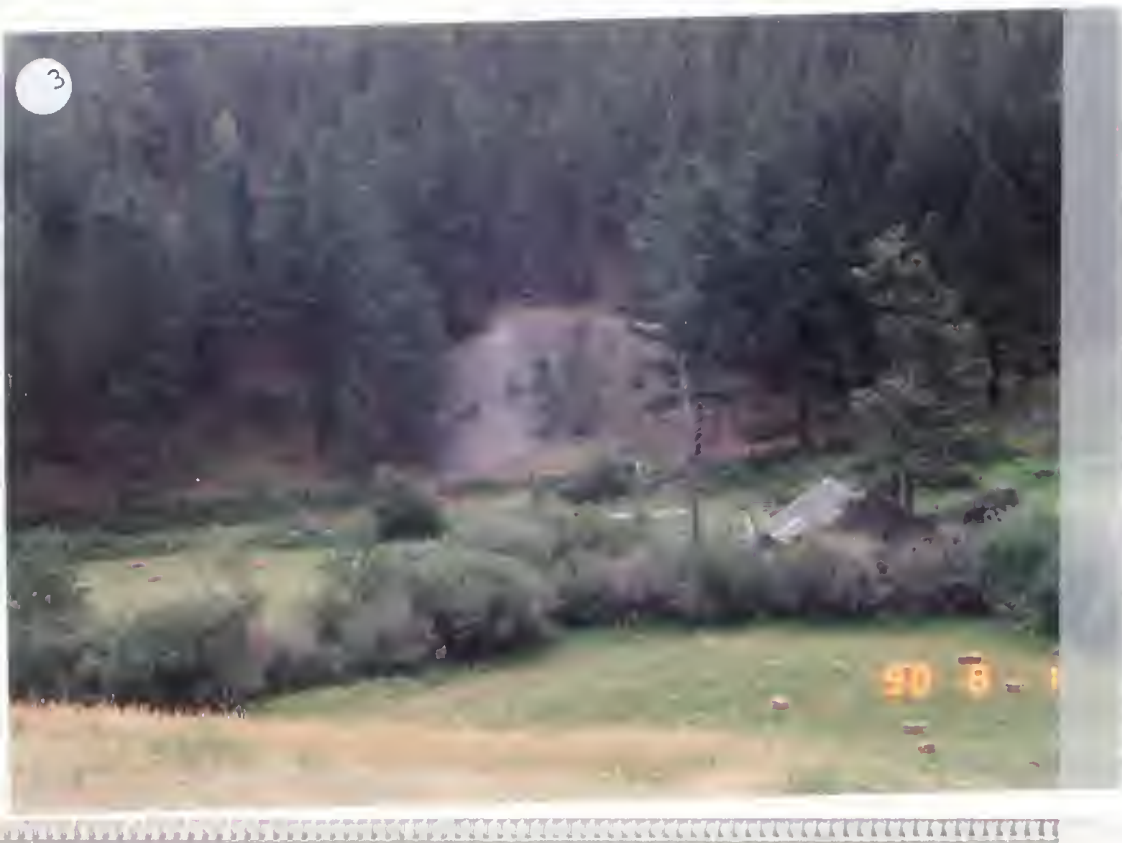
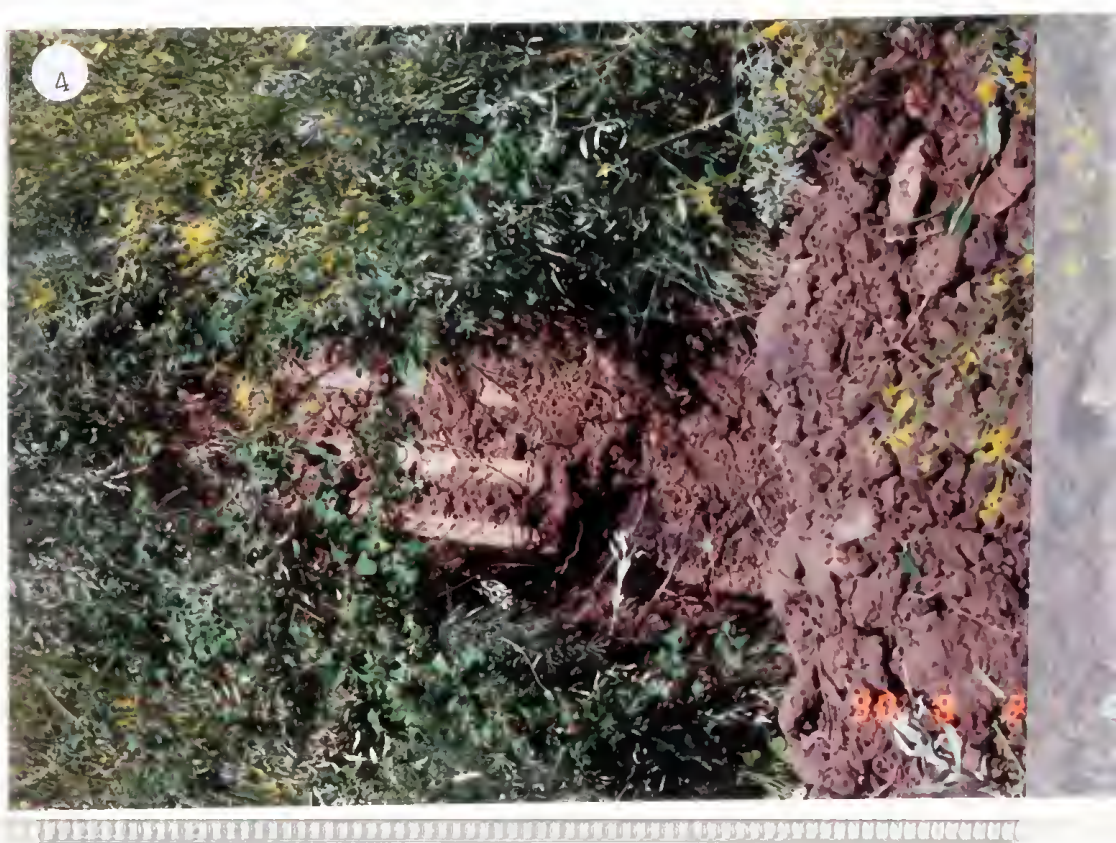
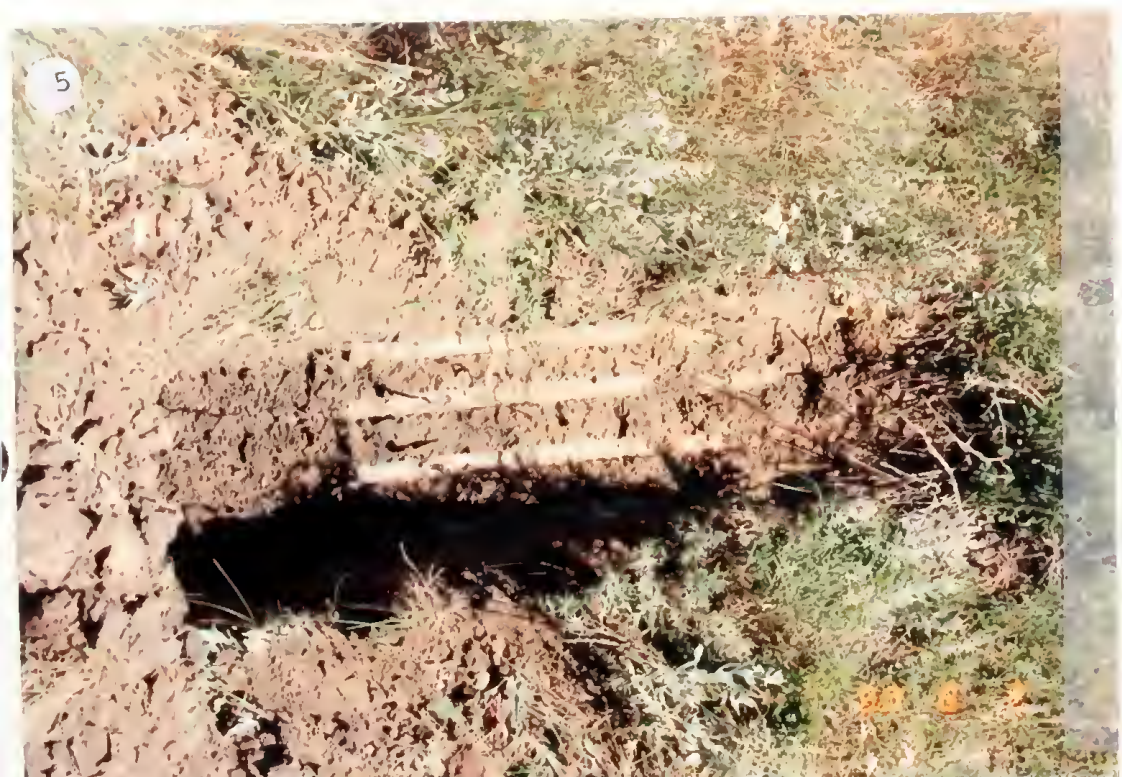
1. Shearson Mines - Site No. 5 Before Construction
2. Shearson Mines - Site No. 6 Subsidied Adit Before Closure
3. Shearson Mines - Site Not Worked
4. Shearson Mines - Site No. 4 Adit Exploration
5. Shearson Mines - Site No. 5 Adit Exploration
